Thermal barrier coatings (TBCs) are used to thermally insulate metallic components of gas turbine engines. As efficiency standards increase, the increased operating temperatures have resulted in the TBCs being chemically attacked by molten sand known as CMAS (calcium-magnesium aluminosilicate). Gadolinium zirconate (GZO) coatings have been shown to have a fast chemical reaction with molten CMAS. Different GZO coatings were studied to identify important microstructural characteristics to prevent CMAS infiltration and protect the underlying Yttria-stabilized zirconia (YSZ) TBC.

## Project Background

**Motivation:** Yttria stabilized zirconia is a common thermal barrier coating used to protect the nickel-based superalloy blades in gas turbine engines. Due to increased operating temperatures in gas turbine engines, YSZ needs protection from calcium-magnesium aluminosilicate. CMAS degrades YSZ by destabilizing the zirconia phase. This phase transformation causes delamination of YSZ after repeated heating and cooling thermal cycles.

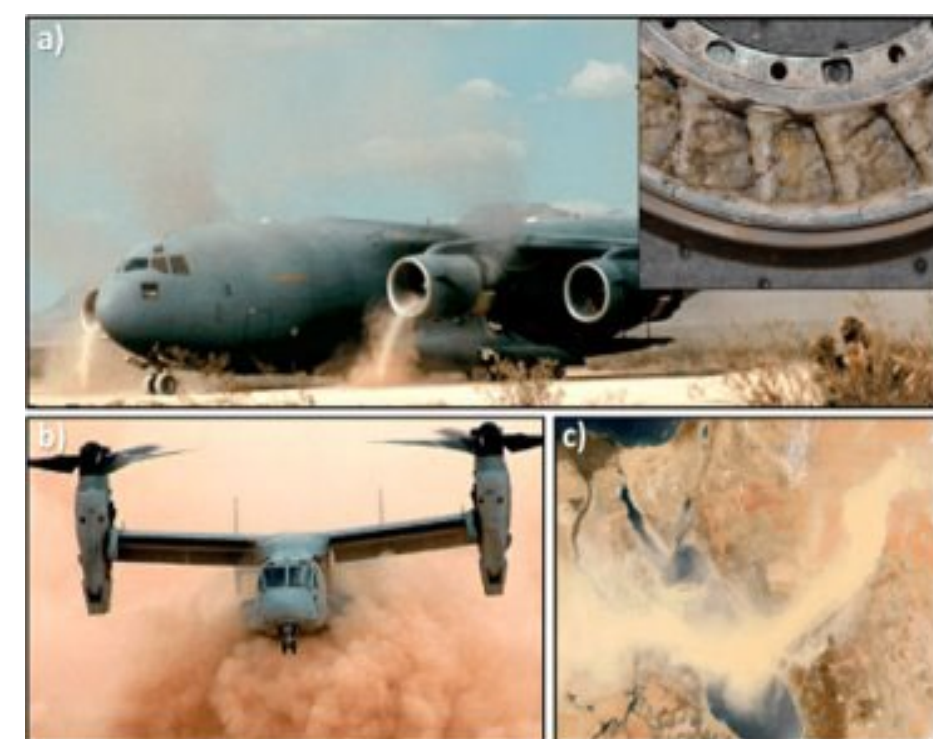
Figure 1: Example of CMAS entering turbine engines.
