One of the biggest causes of loss for rolled metals, including at Logan Aluminum, is edge cracking – a defect formed at the edges caused by an imbalance of forces during the rolling process. This study aims to find the source of edge cracking in rolled aluminum, and attempt to mitigate it through adjustments in the rolling process. Through characterization and analysis of edge cracking throughout different stages of the process, as well as adjusting the surface finish of rolled aluminum, the amount of edge cracking observed changed. It was found that the best rolled sheet metal at the edges came from a smooth surface with no liquation layer. By reducing the amount of liquation layer on the edges, the amount of edge cracking can be reduced.

This work is sponsored by Logan Aluminum, Russellville, KY

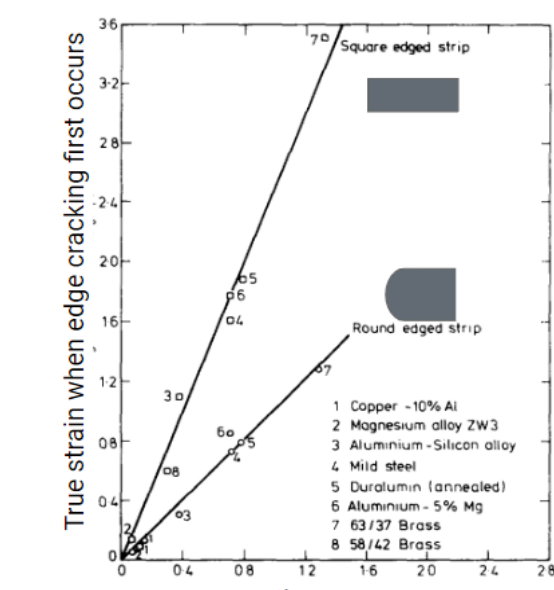
In 1968, Latham and Cockcroft found a linear relationship cracking reduction and reduction in area. Their results can be found on the right. They found that the cracking in materials could be delayed if the edges of strips were lightly machined, since square edges meant that the material would experience compressive forces needed to prevent edge cracking.

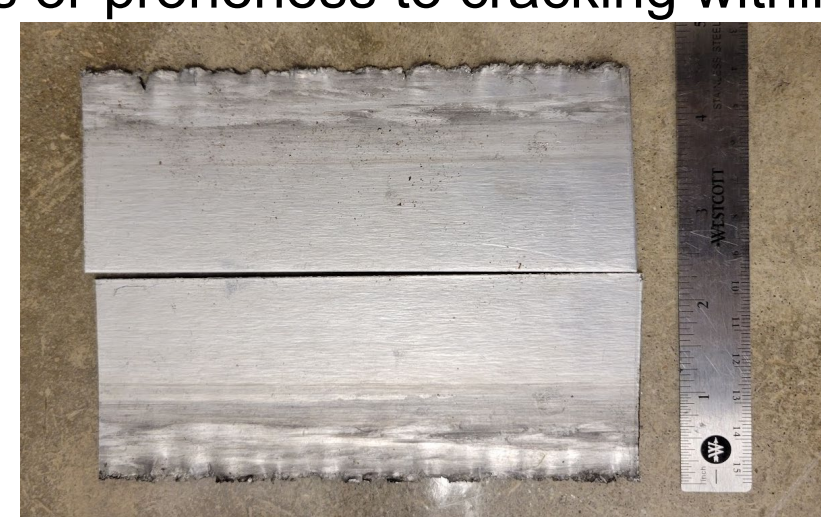
There was also some delamination within the 5182 sample. This separation is along the rolling direction, about two inches in depth. It is suspected to be related to the same problem or mechanics as edge cracking but was outside of the scope of this project. All these problems determined that the reduced ductility and higher hardness of 5182 contribute to it being a more problematic alloy when it comes to edge cracking.

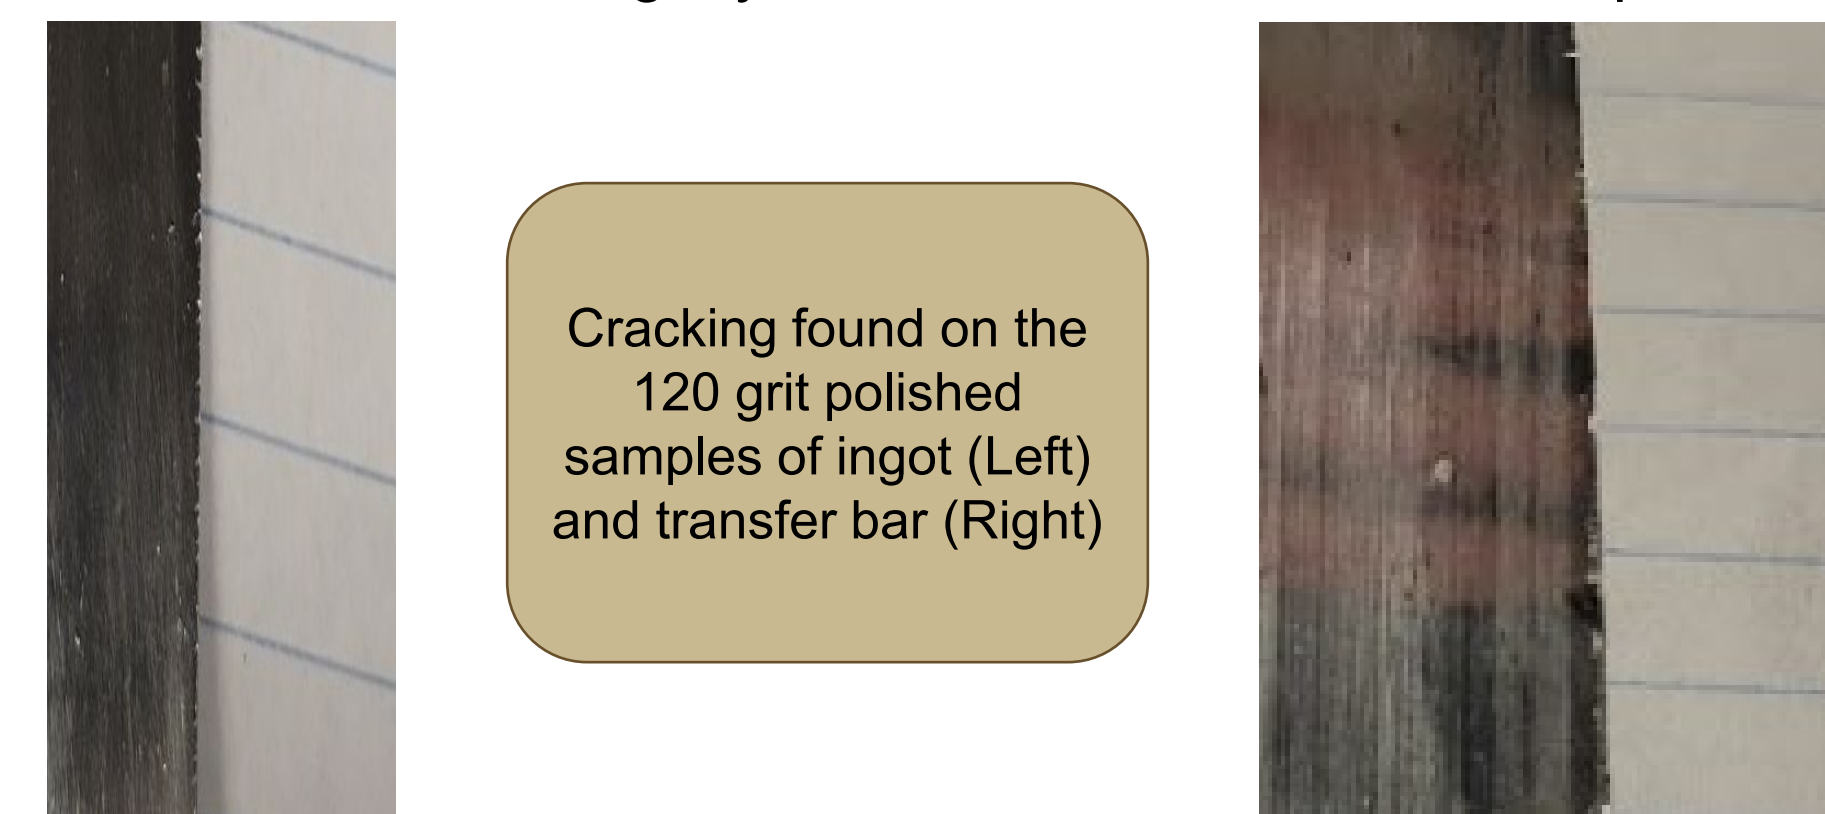
Cracking found on the 120 grit polished samples of ingot (Left) and transfer bar (Right)

When polished with 120 grit, it was found that, when compared to the edge with the liquation layer removed, the onset of edge cracking was hastened in the ingot sample and delayed in the transfer bar sample. Thus, a 120-grit polish is not consistent enough to act as a mitigator for edge cracking.

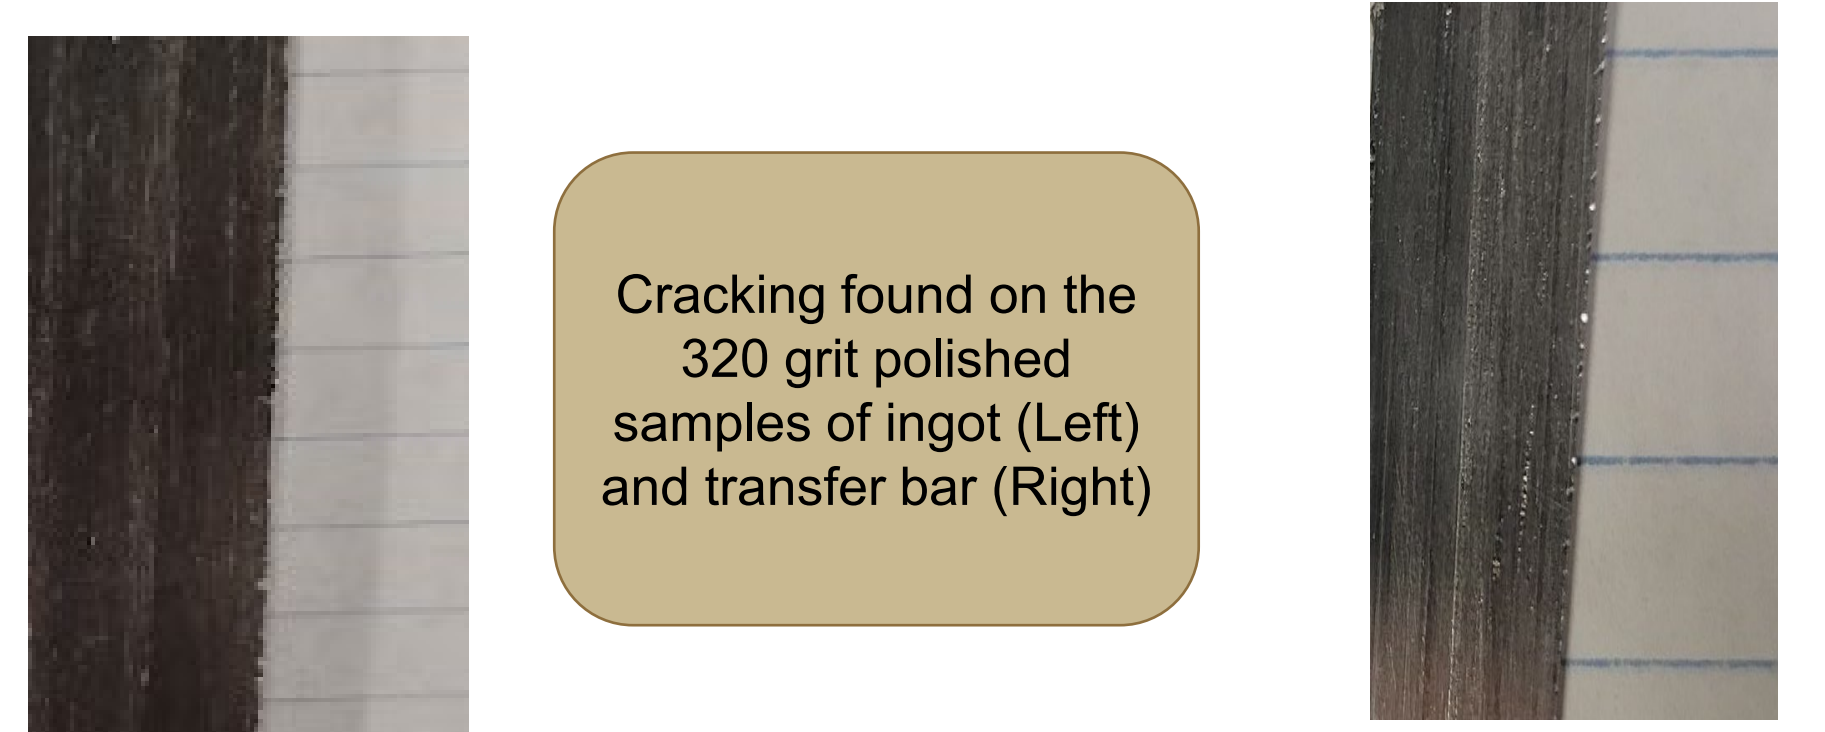
Cracking found on the 320 grit polished samples of ingot (Left) and transfer bar (Right)

When polished with the 320 grit, it was found that the onset of edge cracking was delayed in both the ingot and transfer bar samples, since the higher polish created an ideal condition for the obstruction of edge cracking.

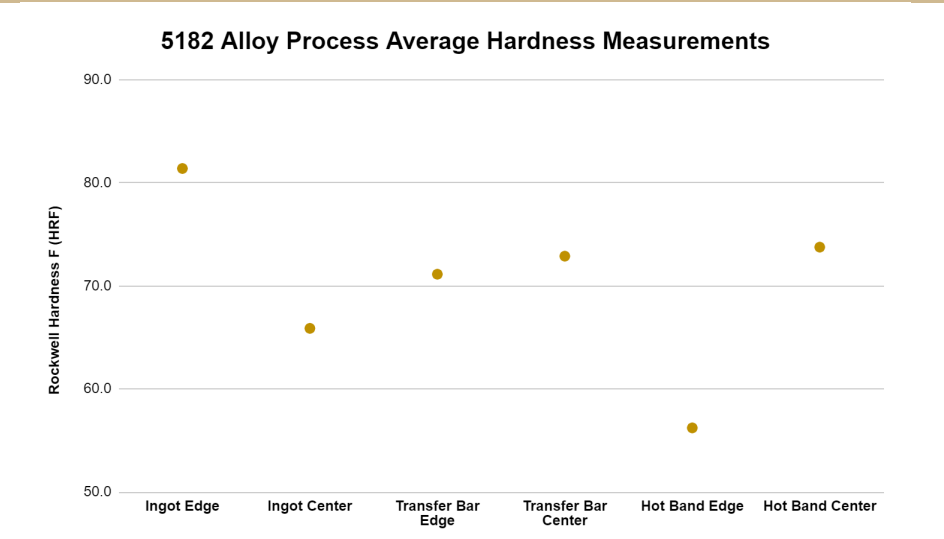
Hardness values of the 5182 ingot, transfer bar, and hot band were first taken in the HRF scale, at both the edge and center of the ingot. Edge values were collected within 1 cm of the edge of the sample, while center values were taken more than 5 cm from the edge.

Generally, as the sample is rolled more, the hardness at the edges decreases while the hardness at the center increases. Since hardness should increase with decreasing grain size when worked, edges may not be rolled enough at Logan.
