Homework H31.A

Homework H31.B

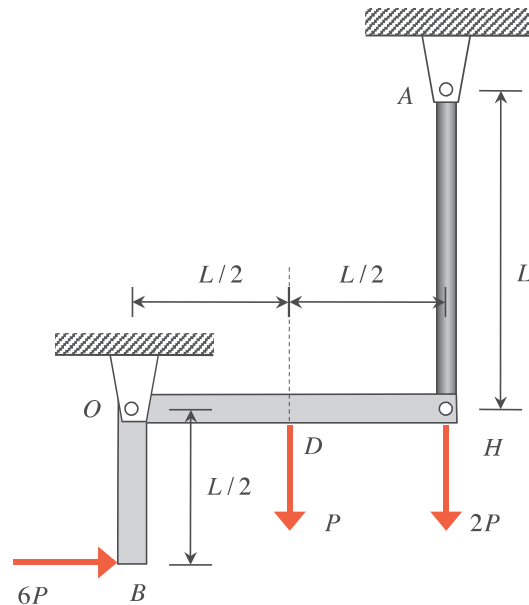
Given: The frame shown below is made up of the L-shaped member BH that is pinned to ground at O. AB is also supported by the rod AH that has a cross-sectional area of A . Member BH carries loads at locations B, D and H, as shown. Rod AH is made up of an aluminum alloy 6061-T6.

For this problem, use the following parameters: $P = 30 \text{ kN}$, $L = 1.5 \text{ m}$ and $A = 100 \text{ mm}^2$.
